**NASA TECHNICAL
MEMORANDUM**

NASA TM-73852

**PRELIMINARY STUDY OF CYCLIC THERMAL SHOCK RESISTANCE
OF PLASMA-SPRAYED ZIRCONIUM OXIDE TURBINE
OUTER AIR SEAL SHROUDS**

December 1977

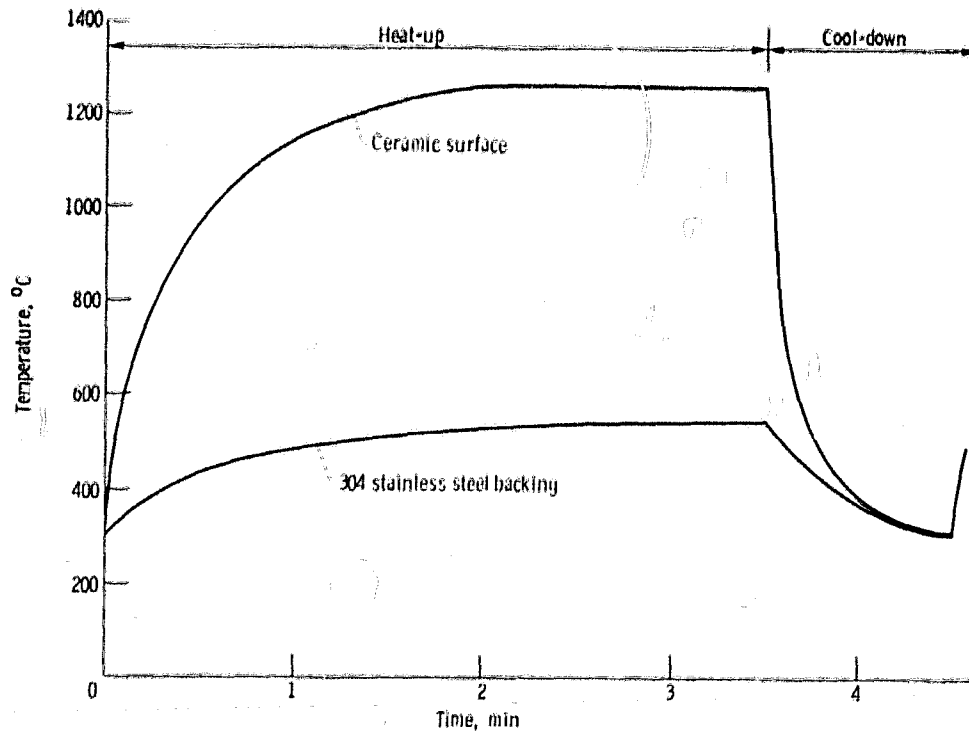
The cyclic thermal shock apparatus is shown in figure 2. An oxygen-acetylene torch provides the means of heating the specimen when it is in the "heat-up" position, with the flame impinging directly onto the ceramic surface at a 90° angle. While the ceramic surface is being heated, cooling air is directed onto the specimen backing. The flame is positioned and tuned so that during the heat-up phase the ceramic surface reaches a stable temperature of about 1260°C within one minute for all seal configurations. Total duration of the "heat-up" phase is $3\frac{1}{2}$ minutes. Cooling air flow to the backing is controlled to $9.0 \times 10^{-4} \text{ M}^3/\text{sec}$ ($2 \text{ ft}^3/\text{min}$) for all specimens, with associated backing temperatures of 480° to 540°C , depending on specimen configuration. Ceramic surface temperatures are monitored by an infra-red pyrometer, and cross-checked by chromel-alumel thermocouples embedded in a few special calibration specimens. Temperatures at other locations in the seal and on the metallic backing are indicated by chromel-alumel thermocouples in all specimens.

Figure 2. - Thermal shock apparatus.

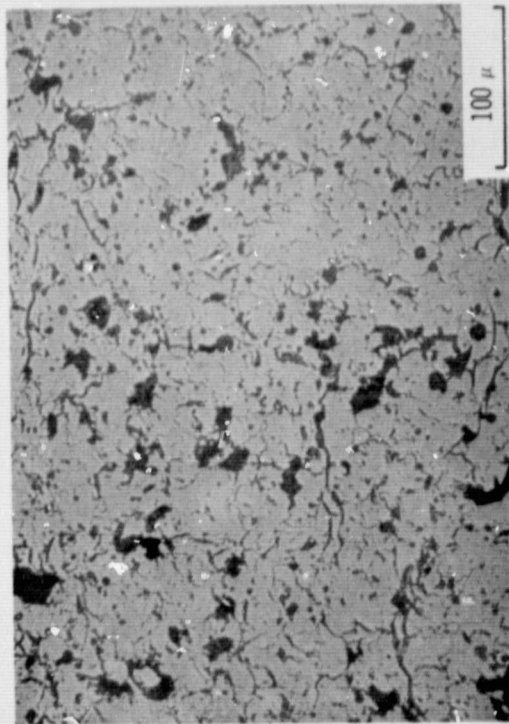
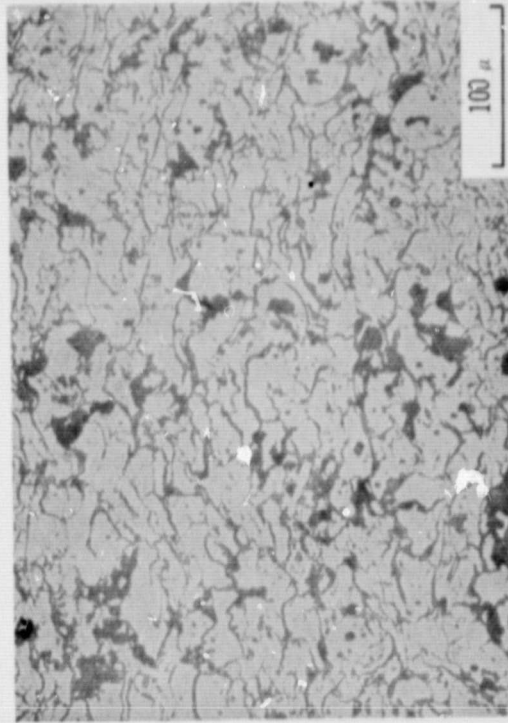
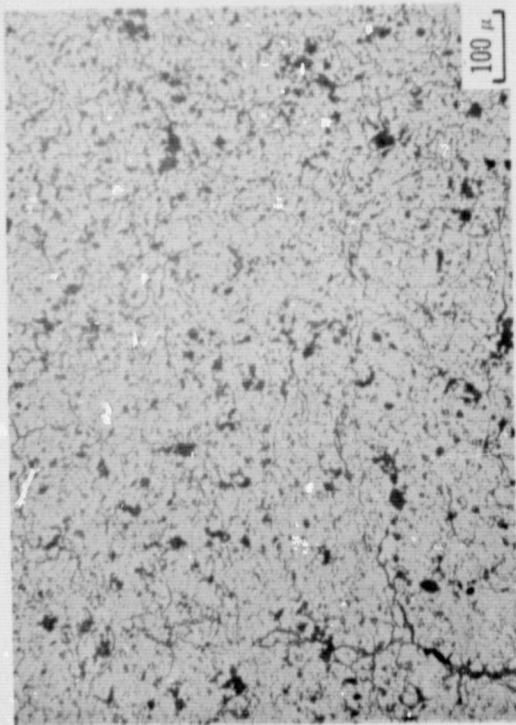
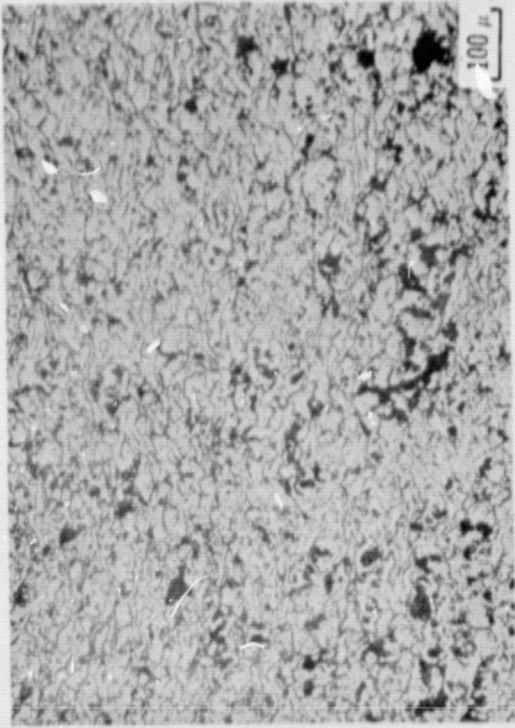
Figure 5. - Microstructure of yttrium stabilized zirconium oxide prepared under standard (a), and reduced intensity (b) plasma-spray conditions.

A second variation of the sprayed metal/ceramic intermediate layer concept incorporated a 2300 μM ZrO_2 layer sprayed under conditions intended to promote increased porosity. From the literature (refs. 3 to 5) it appeared that improved performance could be achieved by increasing the porosity and number of microcracks in the ceramic layer. Through experimentation with the plasma spray process, it was discovered that significantly increased porosity and increased density of microcracks could be consistently obtained by reducing the plasma-spray gun current from 550 to 500 $\text{\AA}$, and increasing the gun-to-workpiece distance from 7.5 cm (3 in.) to 15 cm (6 in.). Comparison of the increased porosity microstructure thus obtained and the standard microstructure is shown in figure 5. In fact, the cyclic life of specimens prepared with the increased porosity ceramic layer is dramatically increased, as shown in figure 4. As many as 51 cycles were accumulated on one such specimen before spallation occurred.

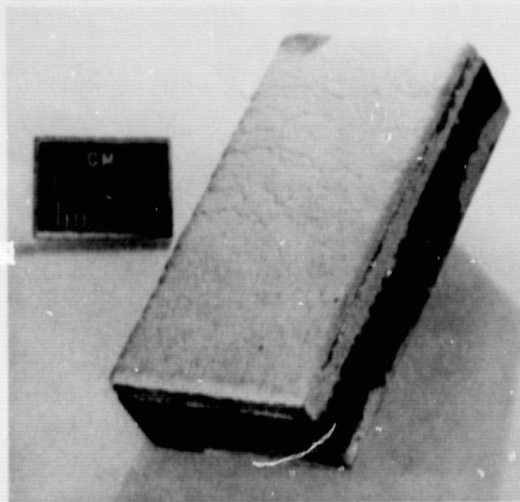
indicated in figure 4. Surface, or "mudflat" cracks were seen on all specimens, as shown in figure 6. Sectioning revealed that the cracks did extend nearly down to the ceramic/intermediate layer interface, as may be seen in figure 7. One of the specimens showed no evidence of laminar cracking (cracks propagating parallel to the ceramic/intermediate layer interface) after 160 thermal shock cycles, while another specimen, after 150 cycles, did show some localized laminar cracking as in figure 7(b). It is believed that spallation is caused by the propagation and coalescence of such laminar cracks. A third specimen was subjected to 455 thermal shock cycles without spallation.

Figure 6. - Ceramic turbine seal system with porous sintered
NiCrAlY intermediate layer after 180 thermal shock cycles.

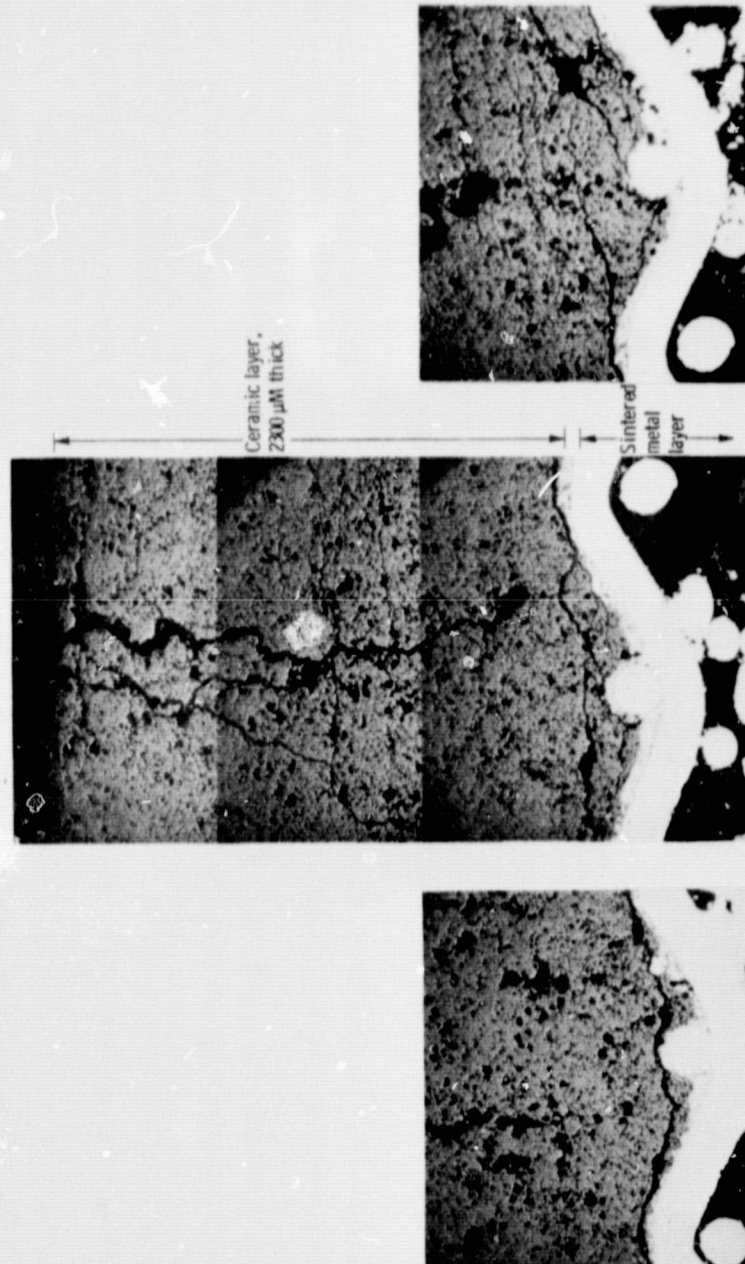
Figure 7. - Section view of specimen with sintered NiCrAlY fiber metal intermetallic layer, after being subjected to 160 thermal shock cycles.
